**DOE ZERO ENERGY READY  
HOME™ CASE STUDY****Weiss Building &  
Development, LLC**Custom Home  
Downers Grove, IL

**Performance Data:**

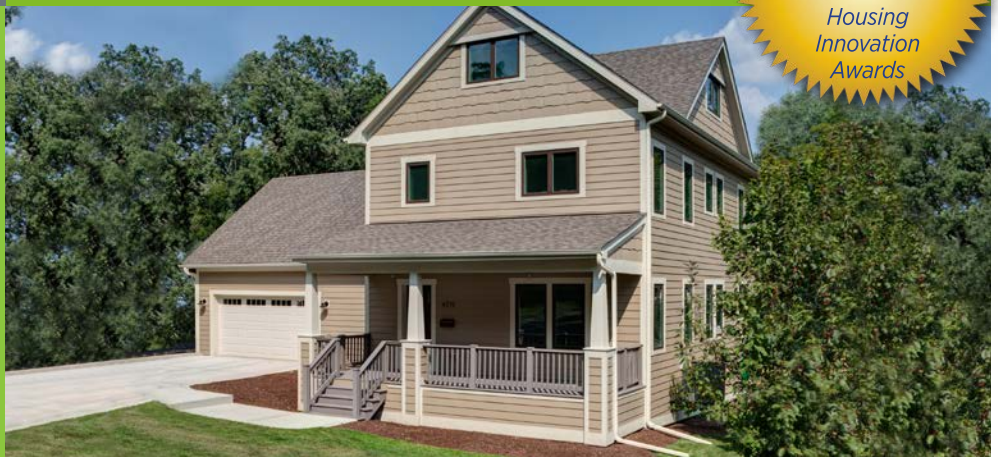
**BUILDER PROFILE****Weiss Building & Development LLC**Brandon Weiss, builder  
South Elgin, IL  
630-485-1818, Brandon@weissbd.com  
[www.weissbd.com](http://www.weissbd.com)**FEATURED HOME/DEVELOPMENT:****Project Data:**

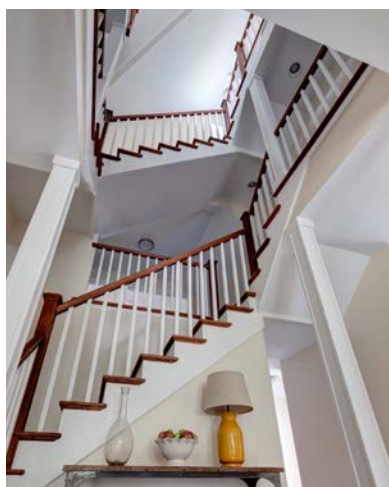
Weiss personally approved every material used in the construction—from the paints and drywall to the cabinets and flooring—to make sure every product met the criteria of the Underwriter Laboratories' GreenGuard Gold standard, ensuring that they are VOC- and formaldehyde-free and nontoxic.
