# Carl Franklin Homes & Green Extreme Homes

5th Street Deep Rehab  
Garland, TX

## BUILDER PROFILE

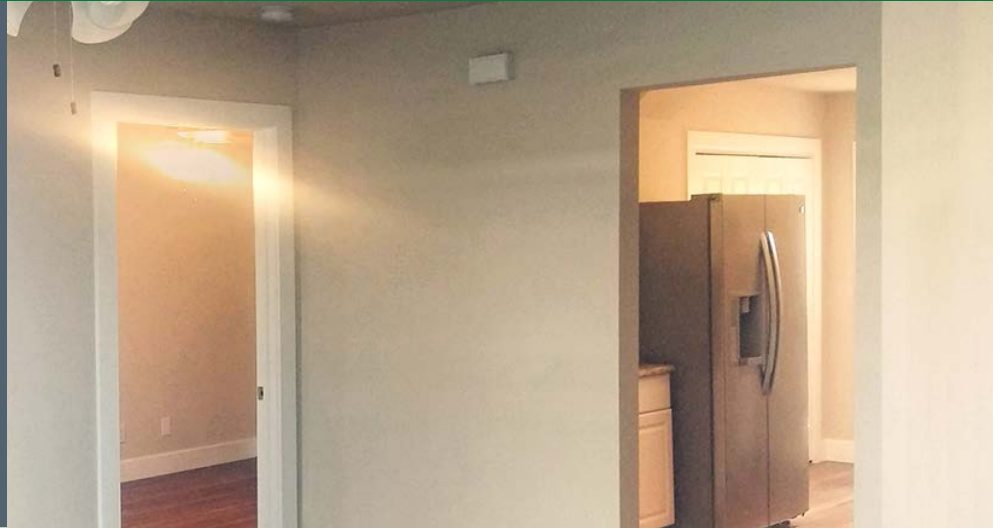
Builder Carl Franklin Homes and non-profit community development corporation Green Extreme Homes (GEH) refurbished this 1,108 ft<sup>2</sup> vintage 1950s home to the high energy efficiency and performance standards of the U.S. Department of Energy's Zero Energy Ready Home program. Triple-pane windows and ENERGY STAR appliances and ceiling fans add to the savings.

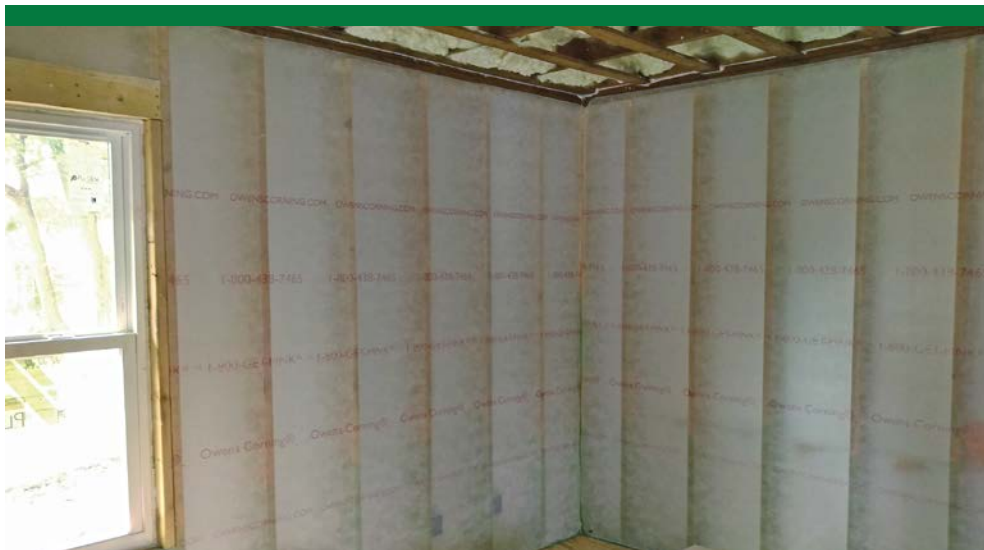
As part of this deep retrofit, the old siding and drywall were removed, then the 2x4 stud walls were sheathed with 0.5 inches of rigid foam, 0.5-inch coated OSB, draining house wrap, and engineered wood siding. The wall cavities were filled with 3.5 inches of dense-packed blown cellulose.

The team completely stripped the home to the studs, removing old siding, dry wall, roofing, and windows. They removed the old rotting wood foundation of the addition. The existing foundation was leveled and the drainage plane was changed to flow water away from the slab. A new additional slab was poured for the new bedroom and bath. Then, they reframed the rest of the exterior walls back on the slab and re-supported the roof with new interior braced walls. The wall cavities were insulated with 3.5 inches of dense-packed blown fiberglass insulation and the exterior of the walls was covered with three layers of protection—a half-inch of rigid EPS foam board, a coated OSB sheathing with seams taped to replace house wrap as the weather-resistant barrier, and a half-inch-thick engineered wood siding product. Together this provided a total wall insulation value of R-21.

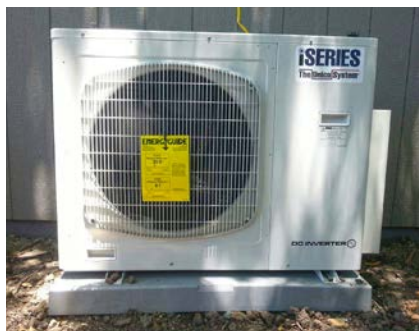
A high-efficiency heat pump provides all of the home's heating and cooling.

The home's HVAC system consists of a ducted high-performance heat pump with a heating efficiency of 9.1 HSPF and a cooling efficiency of 20 SEER. The unit is located in a conditioned closet in the middle of the house and all of the ductwork is in conditioned space in the attic. Because the attic is so low, small-diameter "mini" ducts were used. The ducts were insulated to R-8 and air sealed; duct leakage testing showed 0 leakage to the outside at 25 cfm. An energy recovery ventilator (ERV) with a MERV 10 filter was set on a separate timer from the heat pump to provide fresh air ventilation at levels exceeding the ASHRAE 62.2 requirements for homes.
